## Damage to agricultural facilities

Yoshiyuki Mohri\*, Susumu Masukawa, Toshikazu Hori, Mitsuru Ariyoshi

*Department of Facilities and Geotechnical Engineering, National Institute for Rural Engineering, Japan*

**Abstract**

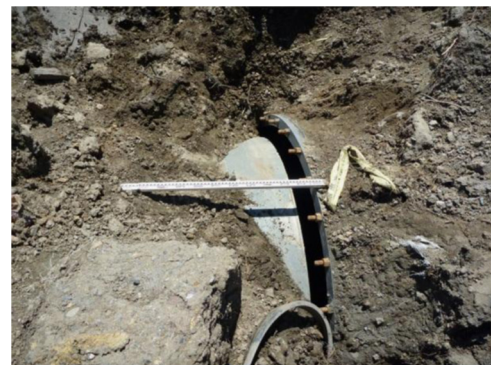
Photo 2. Joint ejection at reducer .

The specially shaped pipe (a steel reducer connecting between  $\Phi 2000$  mm and  $\Phi 2400$  mm diameter pipes) that was installed close to this diversion structure was completely displaced. Due to its gradually tapered diameter, it received an unbalanced load (thrust load) in the pipe-axial direction equivalent to the difference of the diameters of the two pipes it connected, under the action of internal water pressure. During the earthquake, it was estimated that a maximum internal pressure of 0.3 MPa acted on the pipes. As a result, a force of about 406 kN was applied to the reducer. The reducer moved 435 mm toward the  $\Phi 2000$  mm pipe, and was completely ejected, as shown in Photo 2. Leakage from the internal pipe resulted in soil flow, causing a large amount of settlement, which accounted for an area of approximately  $10 \times 10$  m<sup>2</sup>. The ditch on the ground surface in which the pipes were buried settled into grooves, causing axial cracking along the boundary between the backfill and original ground. The ground had

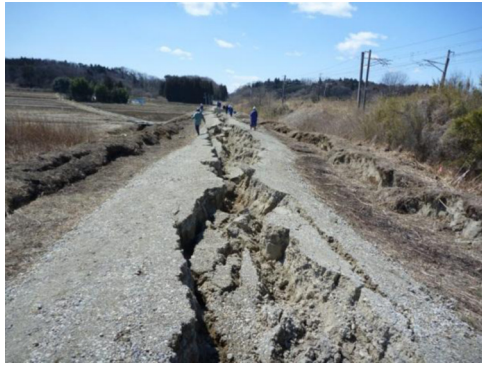
Photo 3. Open crack and settlement of the road above pipeline .

The road under which the pipeline was installed had a large open crack 50 cm in width, and had settled over the 1.4 km line, as shown in Photo 3. According to the measurement, the cracking in the road surface reached a depth of 1.6 m, while there was a bump of up to 700 mm between the road and surrounding ground. The cracking of the road surface occurred at the center of the pipe (road), and the shoulders on the right and left banks became lower than the center. This is attributed to the fact that the pipe floated and the embankment slope failed, causing a landslide. As shown in Photos 4, a 1.5 m bump occurred between the Yabuki minami No. 2 air valve structure and the ground, and signs of sand boiling were observed at the boundary between the structure and the

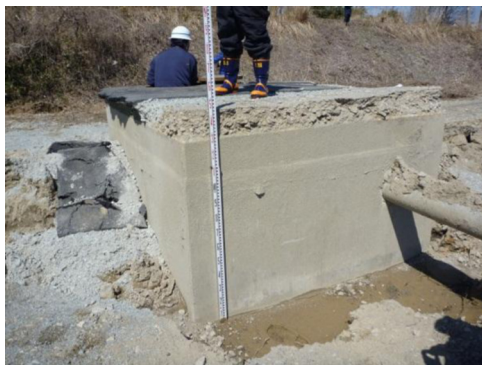
Photo 4. Settlement of ground around manhole .

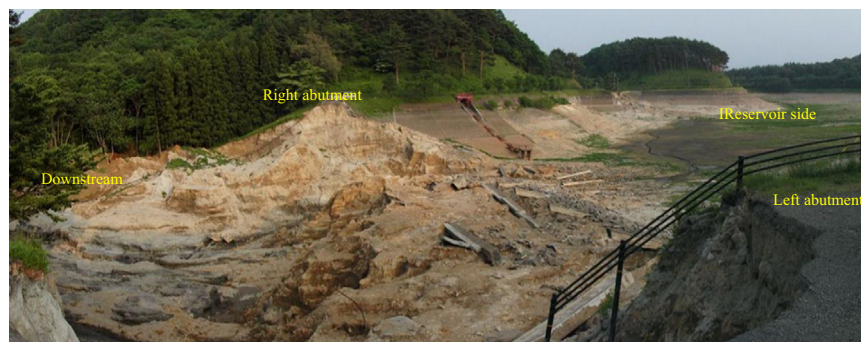
structural design and construction specifications of the dam are those for a small earth dam. The water stored in the Fujinuma reservoir (Fukushima Prefecture, 2011) overflowed and breached the dam because the reservoir, which was full when the earthquake struck, experienced the slide failure of the whole upper embankment from the right to the left abutment during the earthquake (Photo 5). As a result of the breach, severe damage to houses located downstream occurred.

Photo 5. Fujinuma small dam after breach.

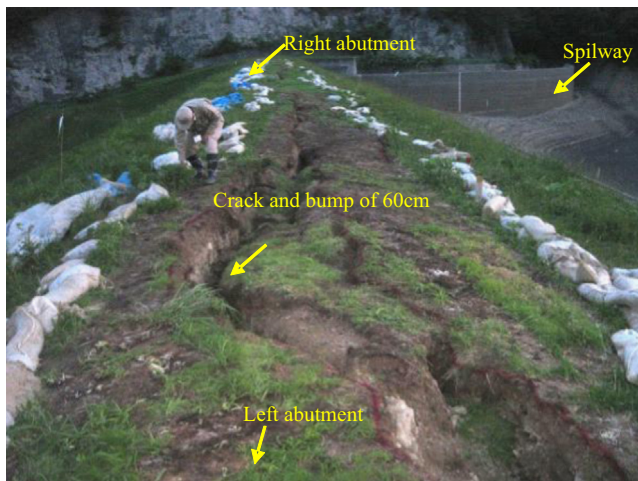
The Mitsumori small dam was full when the earthquake struck, and a longitudinal crack about 130 m long formed on the crest of dam as shown in Photo 7. On the dam on both sides of this longitudinal crack, the upstream side settled lower than the downstream side, forming a step with maximum height of about 60 cm. The concrete vertical parapet on the upstream slope shoulder fell slightly, and this deformation ripped up the masonry directly below the parapet in a scale-like pattern. On the downstream slope about 11 m below the crest, the masonry bulged outwards over the entire dam axis direction (Photo 8). The longitudinal crack on the crest of dam might actually be two cracks. One could have been caused by

Photo 7. Longitudinal cracks on the crest of the Mitsumori small dam.

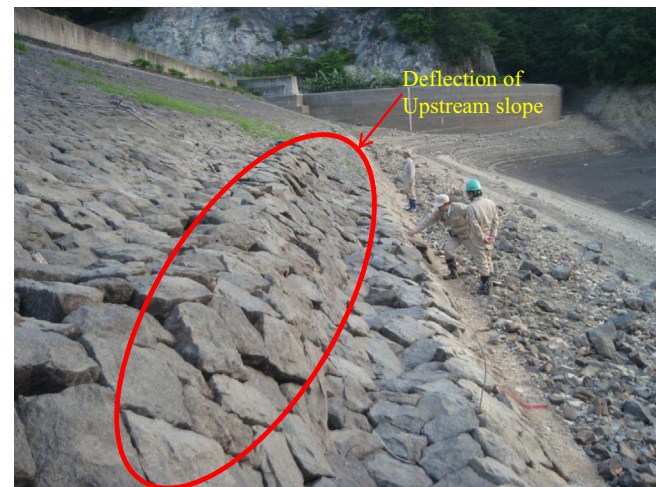
Photo 8. Deformation of stone protection on the upstream slope of the Mitsumori small dam.

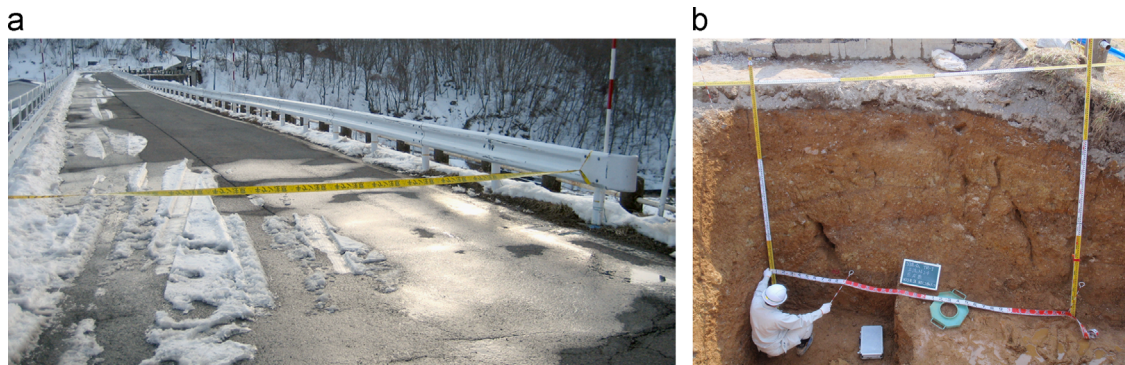
Photo 9. (a) Crack of asphalt pavement road on the crest of the Hatori dam and (b) trench investigation at the cracks on the crest of dam (Tohoku Regional Agricultural Administration Office).

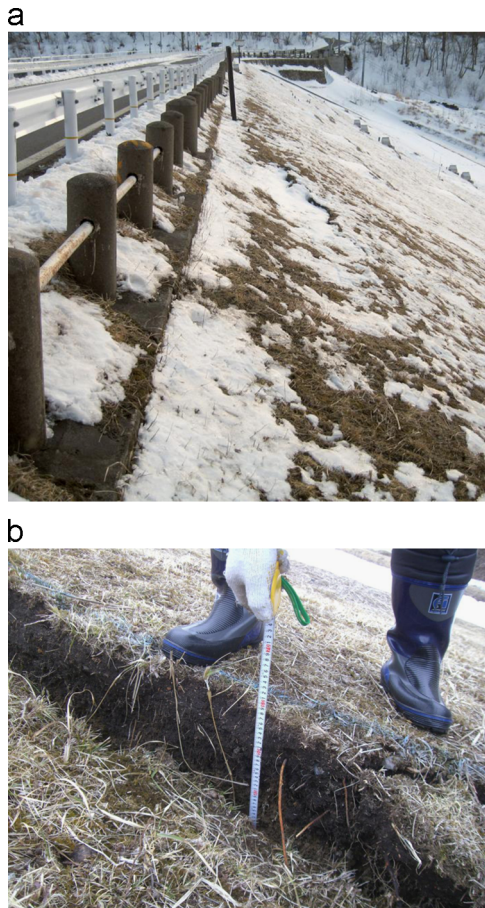
Photo 10. (a) deformation at the top of downstream slope of the Hatori dam and (b) ramp crack on downstream slope (Tohoku Regional Agricultural Administration Office).

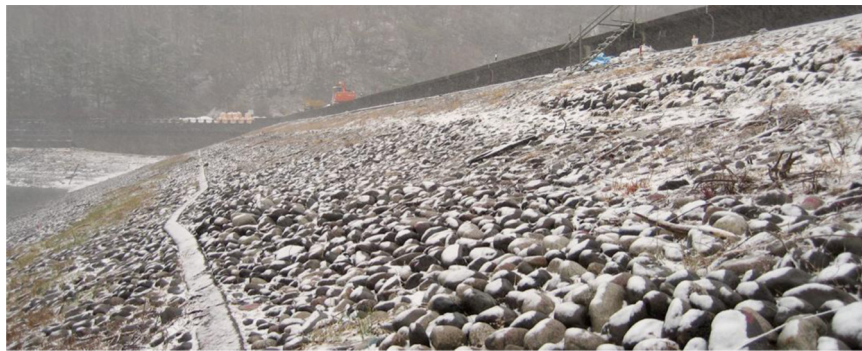
A horseshoe-shaped pocket with maximum settlement of 550 mm was formed on the upstream slope below 2 and 3 m from the parapet foundation. This pocket appeared by moving the riprap materials to downwards. A concrete frame installed on the slope below this deformation was bent downwards, the boulders has risen at the concrete frame that was bent (Photo 11). Backfill consisting of small round gravel, which was embanked parallel to the slope, existed under the bottom of the boulders in the three exploratory trench of the upstream slope. An embankment with a thickness of about 1 m, including a continuous softened layer with a high water content, was embanked in parallel to the slope under the backfill. The average degree of compaction of this embankment was about 75%, obtained by an in situ density test at an exploratory trench and a compaction test in a laboratory. The embankment under the approximately 1 m thick embankment was well compacted clay. The cone penetration resistance of this embankment ranged between 1000 and 1500  $\text{kN/m}^2$  in situ, and

Photo 11. Horseshoe-shaped pocket and bending of concrete frame on upstream slope of the Nishigo dam.
